RM No. E7J23

RESEARCH MEMORANDUM

CYCLIC ENGINE TEST OF CAST VITALLIUM TURBINE BUCKETS - I

By J. Elmo Farmer, F. N. Darmara
and Francis D. Poulson

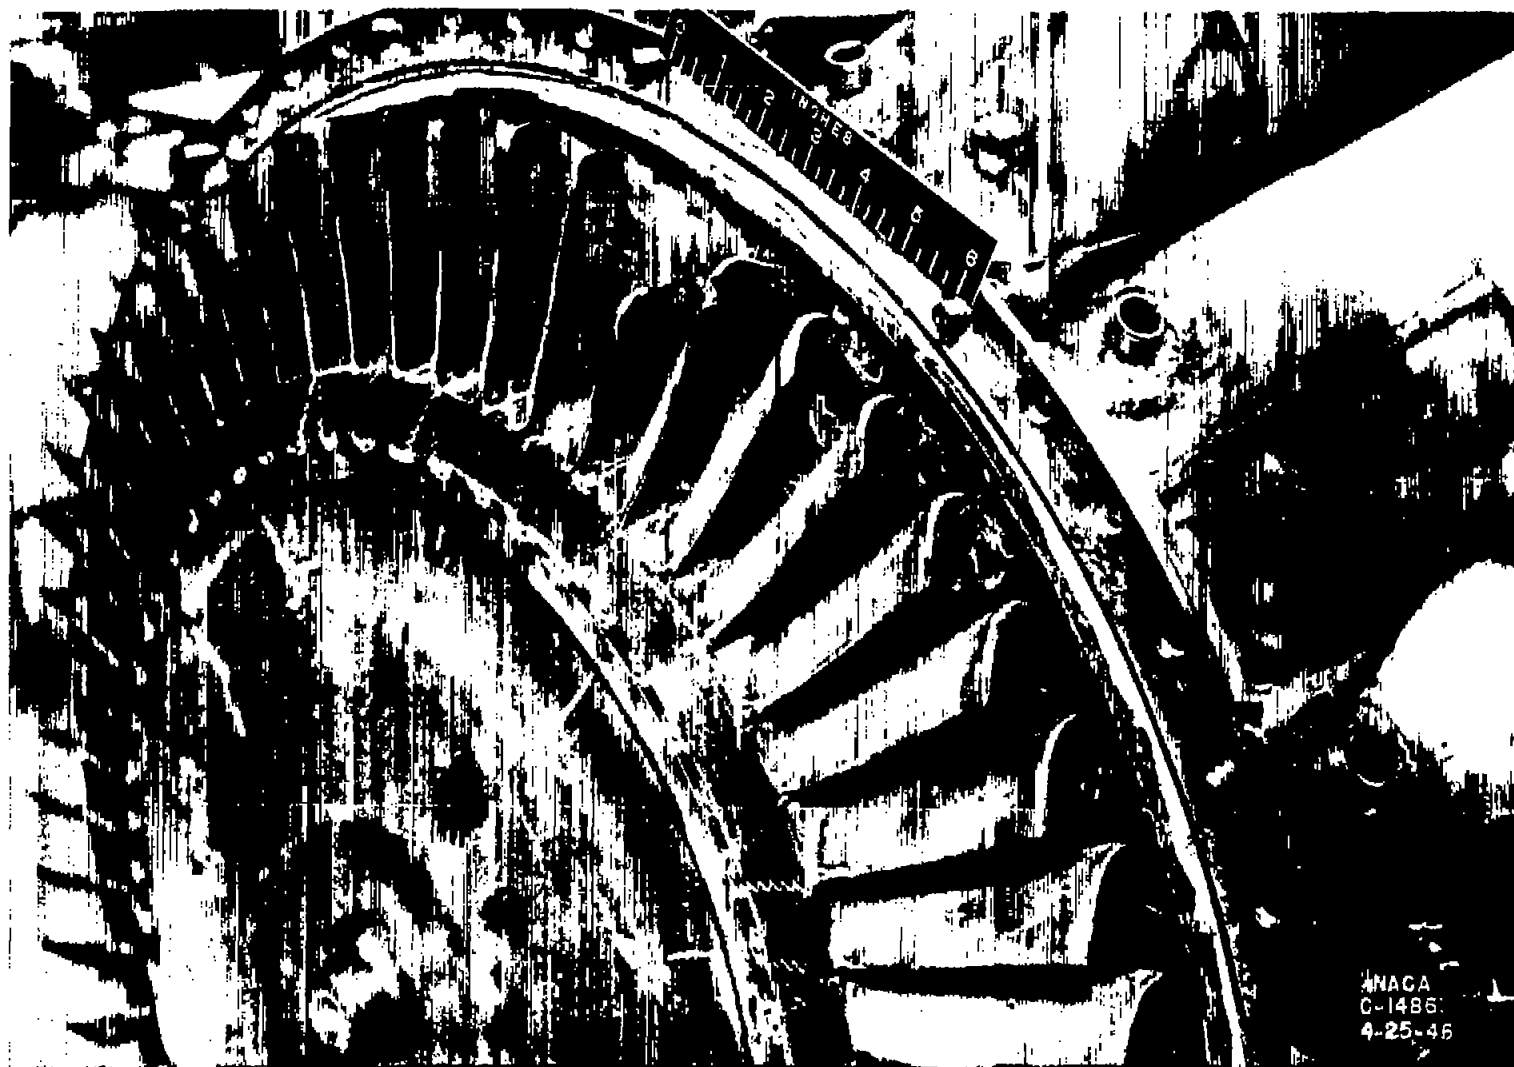
Wheel 1. - Wheel 1 was installed in an engine and was run-in by the engine manufacturer prior to the tests at the Cleveland laboratory. The first failure on wheel 1 occurred during cycle 22 after 7 hours and 20 minutes. The broken bucket (bucket 1-13), shown in figure 6, was replaced, the wheel rebalanced, and the runs

Figure 6. - Wheel 1 after first bucket failure (bucket 1-13), which occurred during cycle 22 (7 hr, 20 min).

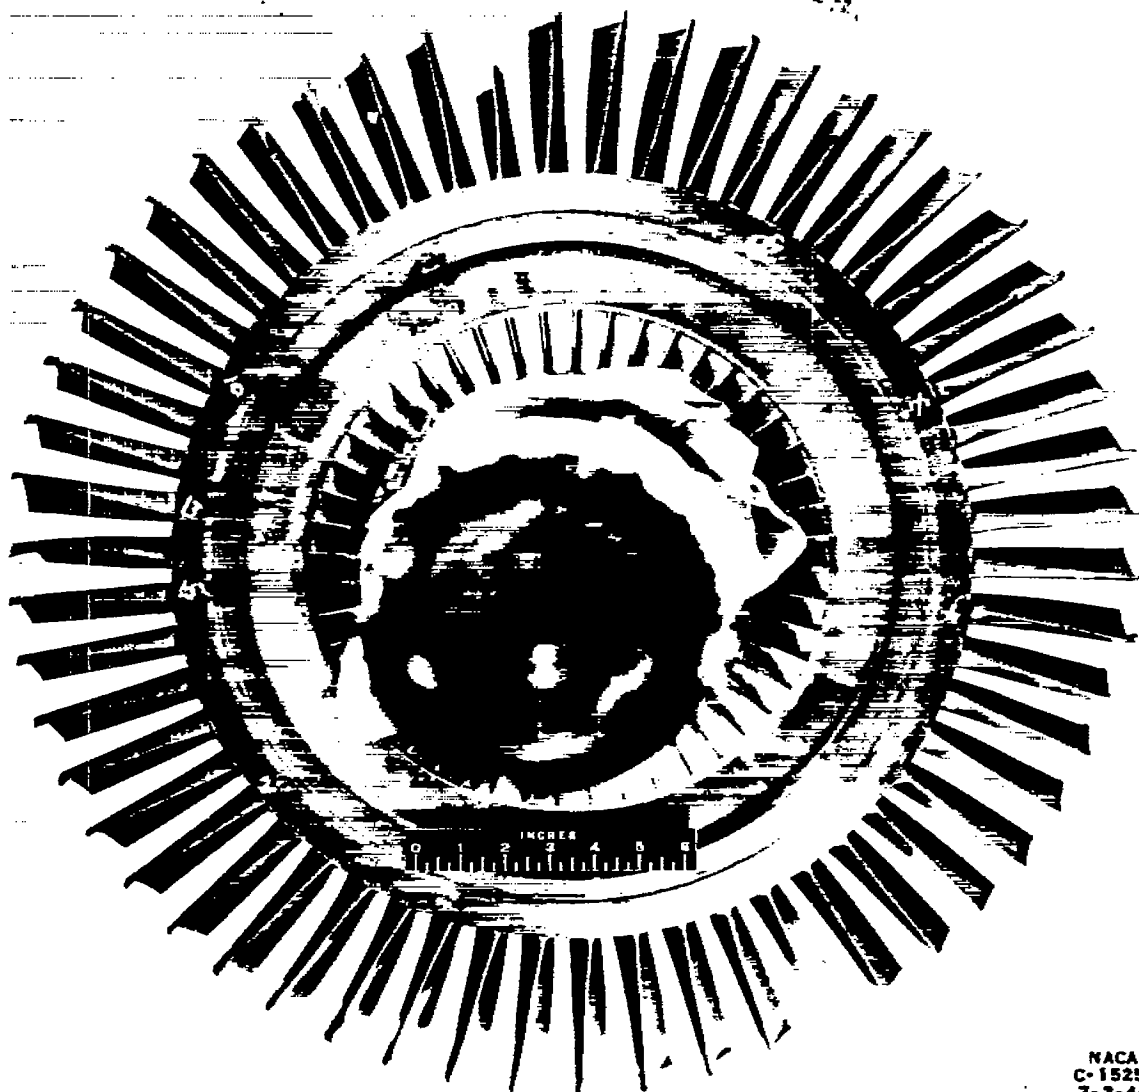
continued. Bucket 1-2 failed three cycles later during cycle 25 after a total running time of 8 hours and 12 minutes (fig. 7). Buckets 1-12 and 1-14 were removed for comparison with the broken buckets.

Figure 7. - Wheel 1 after second bucket failure (bucket 1-2) which occurred during cycle 25 (8 hr, 12 min).

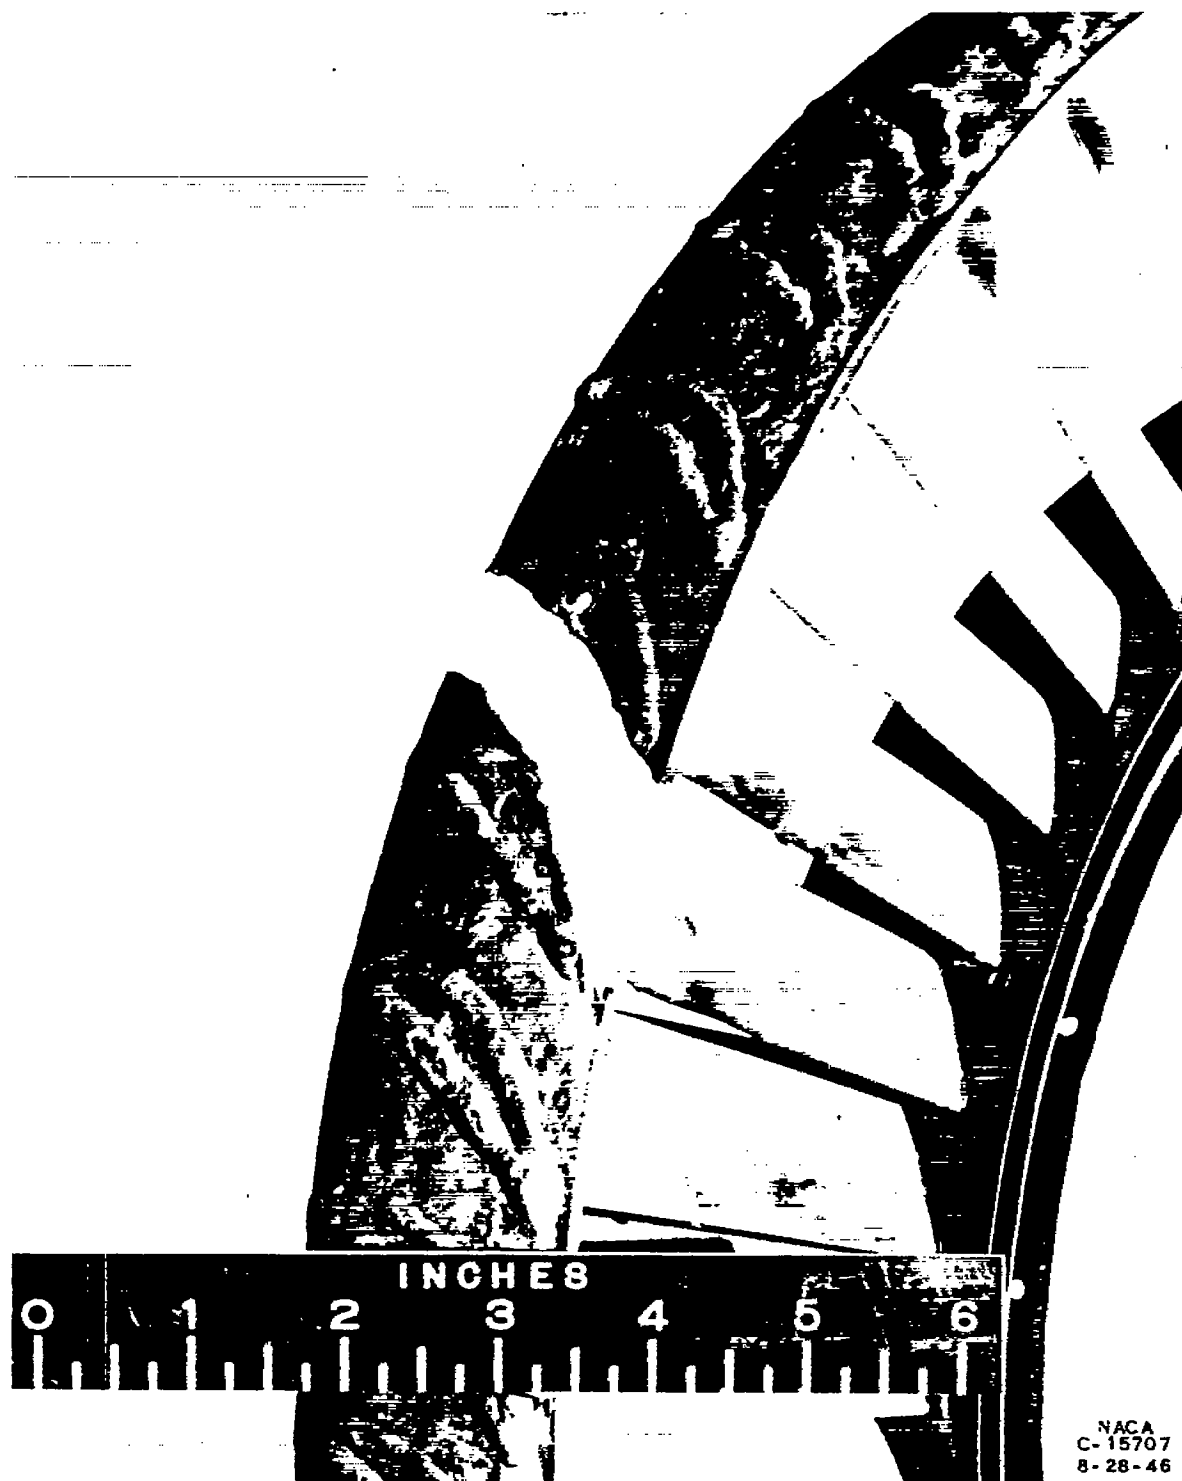
After 11 hours and 8 minutes, the ring-and-tube assembly was found to be so badly damaged that the engine could not be run. The damage sustained by one of the outer flame tubes is shown in figure 9. Operation was resumed after the ring-and-tube assembly had been replaced. An inspection after a total running time of 28 hours and 44 minutes showed that the nozzle diaphragm had been badly eroded (fig. 10) and that the stiffeners on the compressor cover plate were cracked.

Figure 10. - Damaged turbine-nozzle diaphragm from engine after 28 hours and 44 minutes.

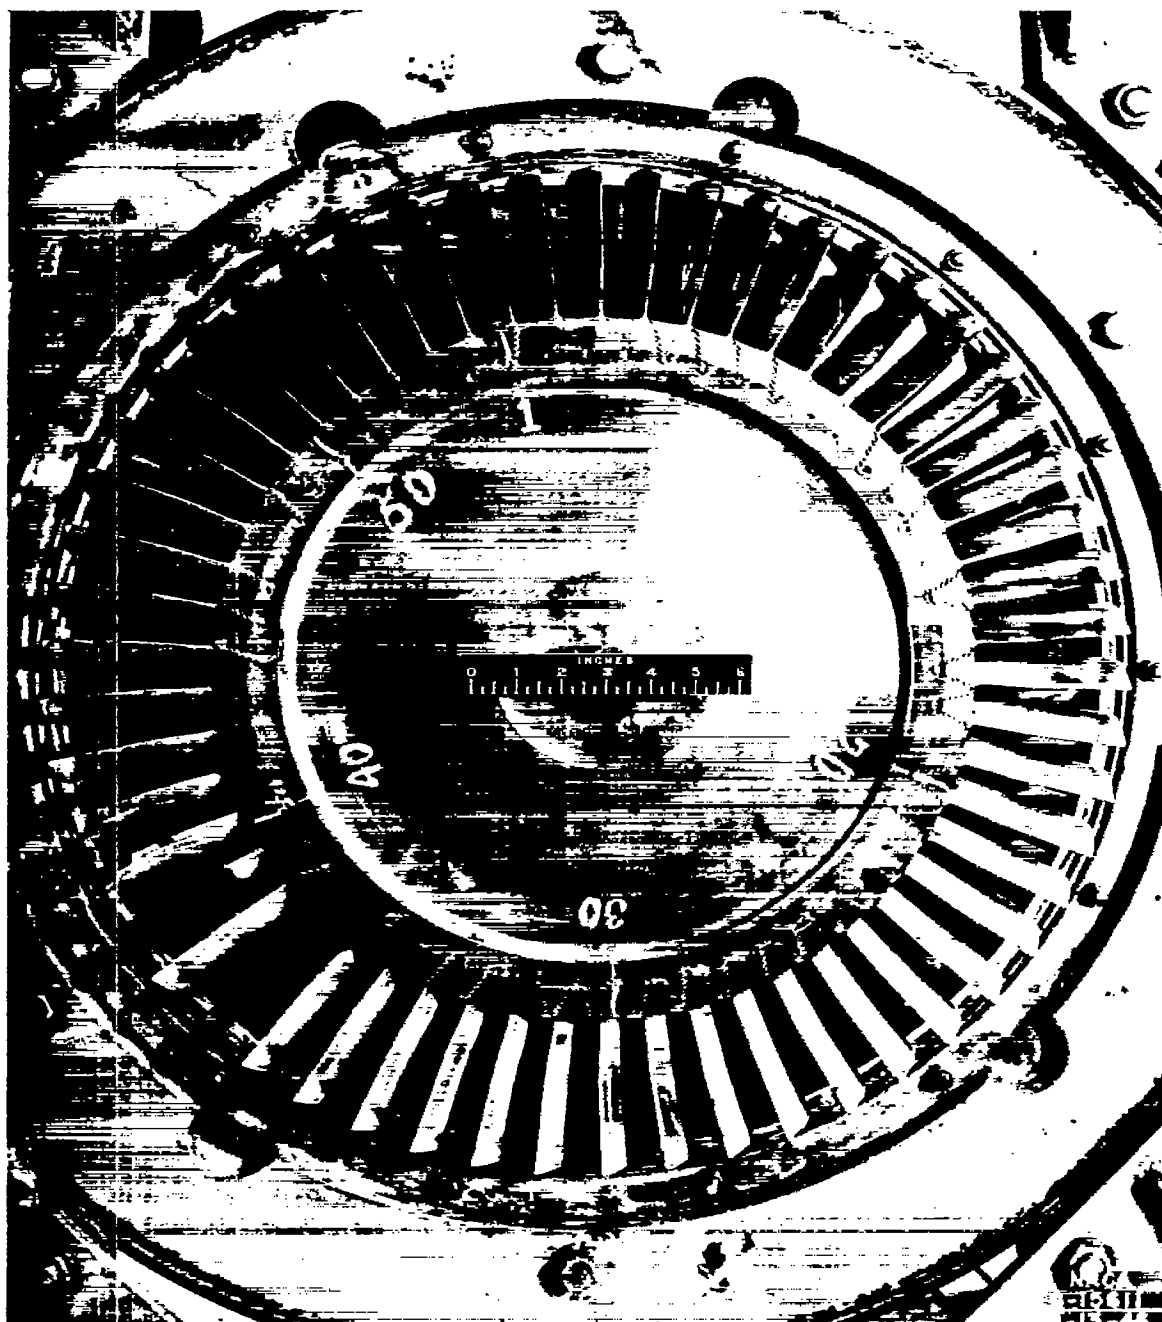
The turbine wheel was therefore removed, installed in another engine, and the running resumed. After cycle 229 (76 hr, 20 min total running time), the nozzle diaphragm was again found to be in bad condition and the engine was removed from the test cell for overhaul. No bucket failure had occurred. Many of the buckets had shifted in the axial direction, six of them sufficiently to rub on the gas baffle in the exhaust cone (fig. 11). Two buckets (buckets 3-16 and 3-43) were removed from wheel 3 for comparison with the broken buckets from the other wheels.

Figure 11. - Wheel 3 after a total running time of 76 hours and 20 minutes showing axial shift of buckets.
